3-YEAR ASBESTOS RE-INSPECTION REPORT

WILLIAM PRESCOTT ELEMENTARY SCHOOL SCRANTON, PA

**SCRANTON SCHOOL DISTRICT
425 North Washington Avenue
Scranton, Pa. 18505**

PROJECT: #SSD.19_751

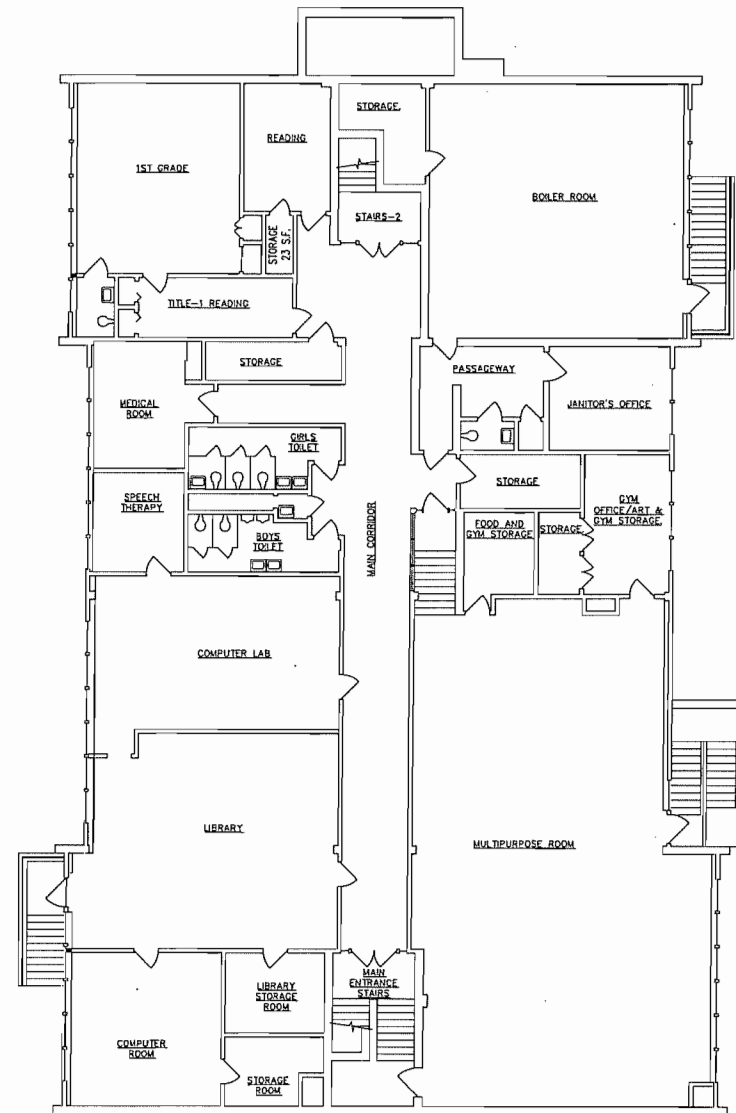
BASEMENT PLAN
NOT TO SCALE

1. EXTERIOR COATING OF EXISTING SINKS

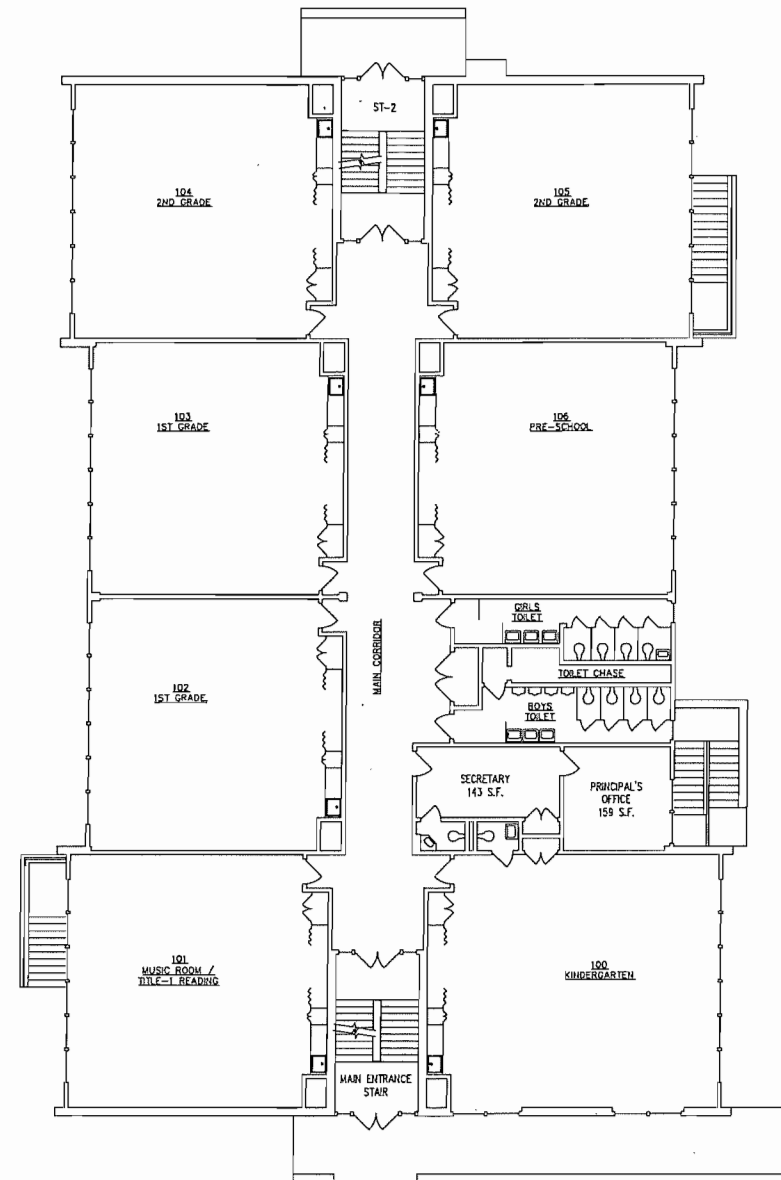
1ST FLOOR PLAN
NOT TO SCALE

1. EXTERIOR COATING OF EXISTING SINKS

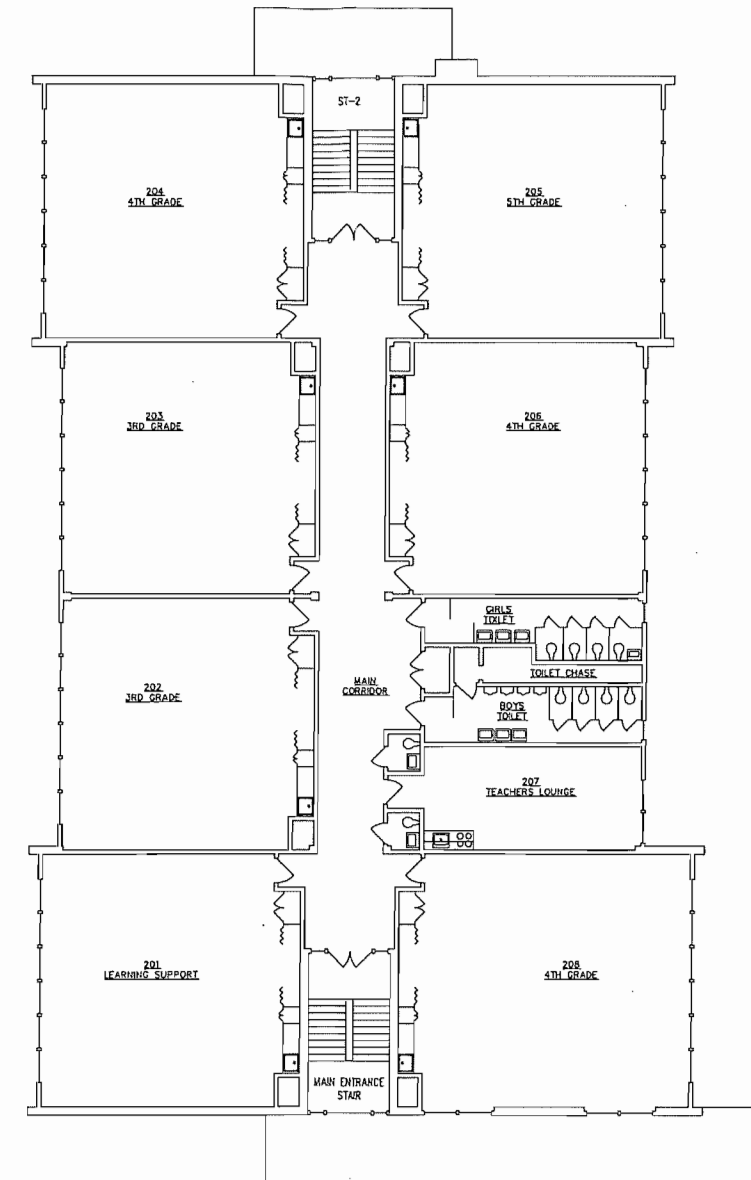
2ND FLOOR PLAN
NOT TO SCALE

1. EXTERIOR COATING OF EXISTING SINKS

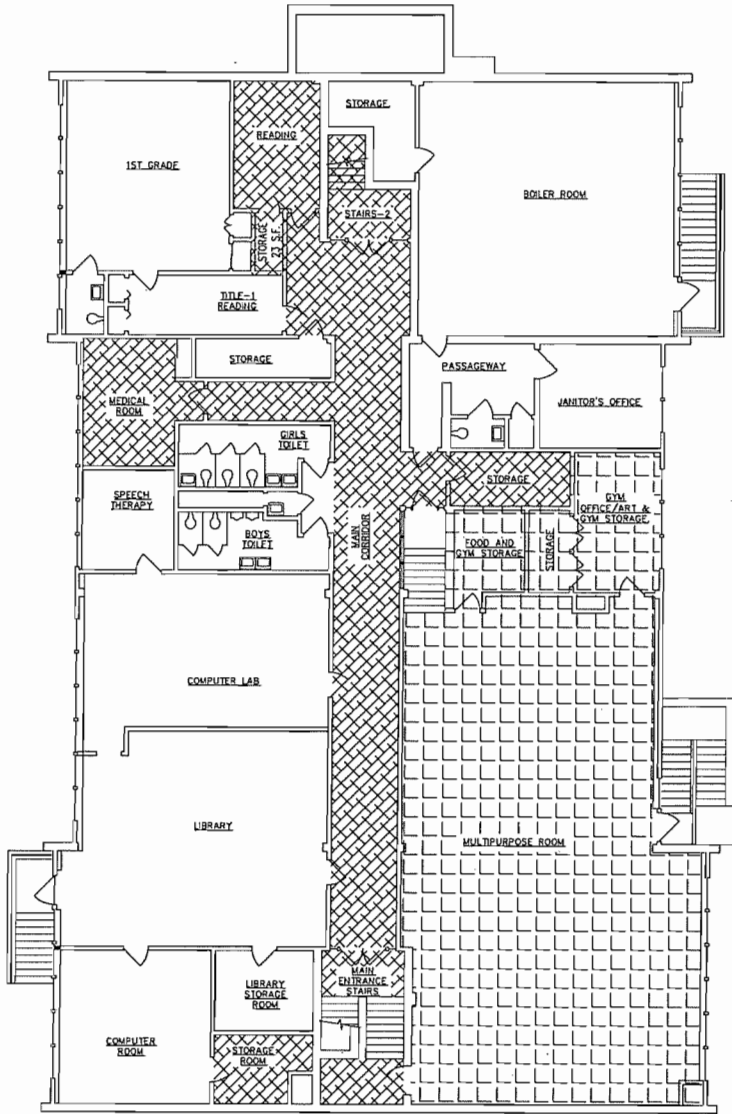
BASEMENT PLAN
NOT TO SCALE

1. ALL MASTIC UNDER ALUMINUM WINDOW FRAMES
2. CHALKING BETWEEN GREEN PANELS
3. DUCTWORK FLEX CONNECTIONS
4. EXTERIOR WINDOW GLAZING
5. DOOR FRAME CAULKING
6. EXPANSION JOINTS
7. CHALKBOARD MASTIC
8. VAPOR BARRIERS (MAY BE PRESENT)

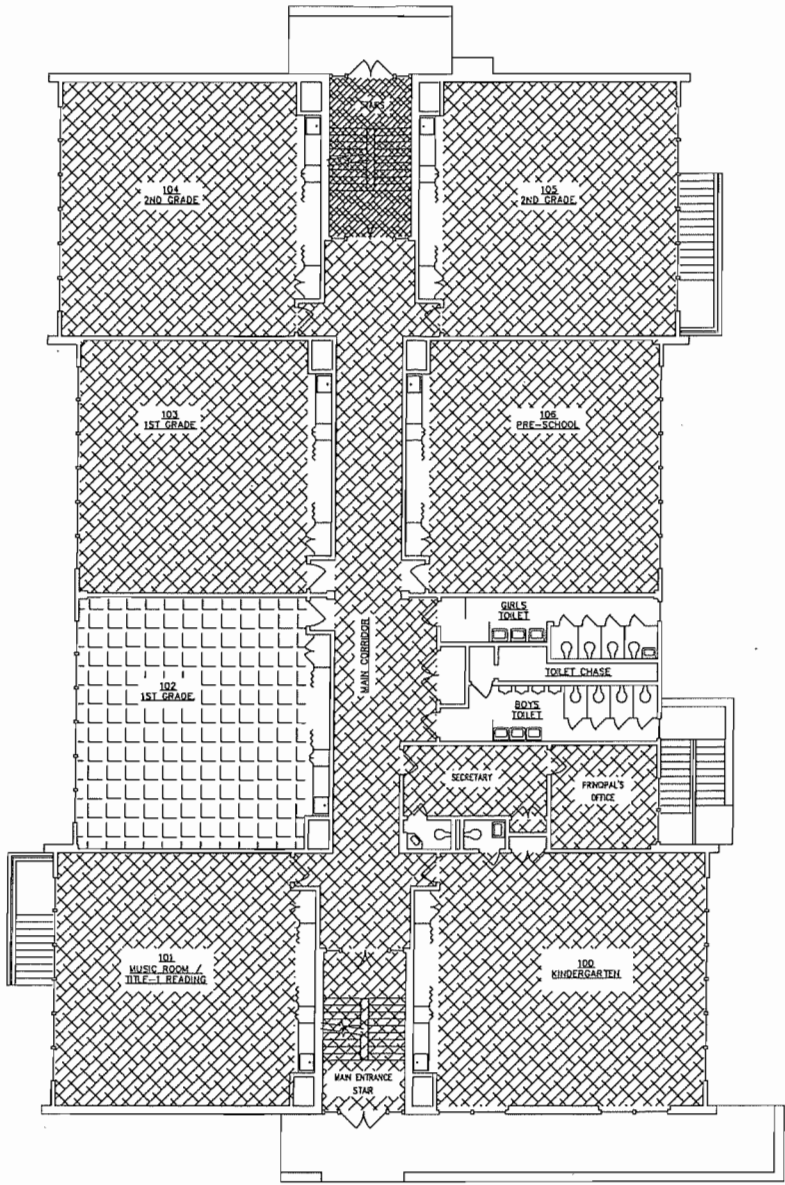
1ST FLOOR PLAN
NOT TO SCALE

1. ALL MASTIC UNDER ALUMINUM WINDOW FRAMES
2. CHALKING BETWEEN GREEN PANELS
3. DUCTWORK FLEX CONNECTIONS
4. EXTERIOR WINDOW GLAZING
5. DOOR FRAME CAULKING
6. EXPANSION JOINTS
7. CHALKBOARD MASTIC
8. VAPOR BARRIERS (MAY BE PRESENT)

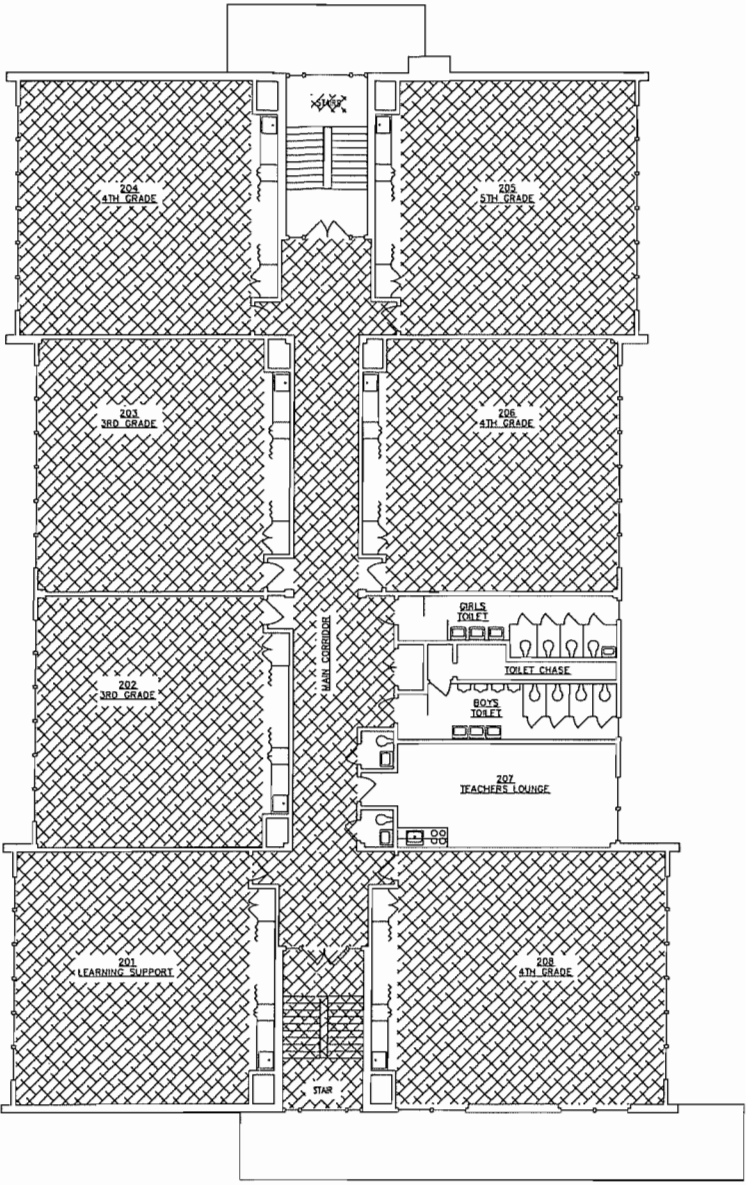
2ND FLOOR PLAN
NOT TO SCALE

1. ALL MASTIC UNDER ALUMINUM WINDOW FRAMES
2. CHALKING BETWEEN GREEN PANELS
3. DUCTWORK FLEX CONNECTIONS
4. EXTERIOR WINDOW GLAZING
5. DOOR FRAME CAULKING
6. EXPANSION JOINTS
7. CHALKBOARD MASTIC
8. VAPOR BARRIERS (MAY BE PRESENT)

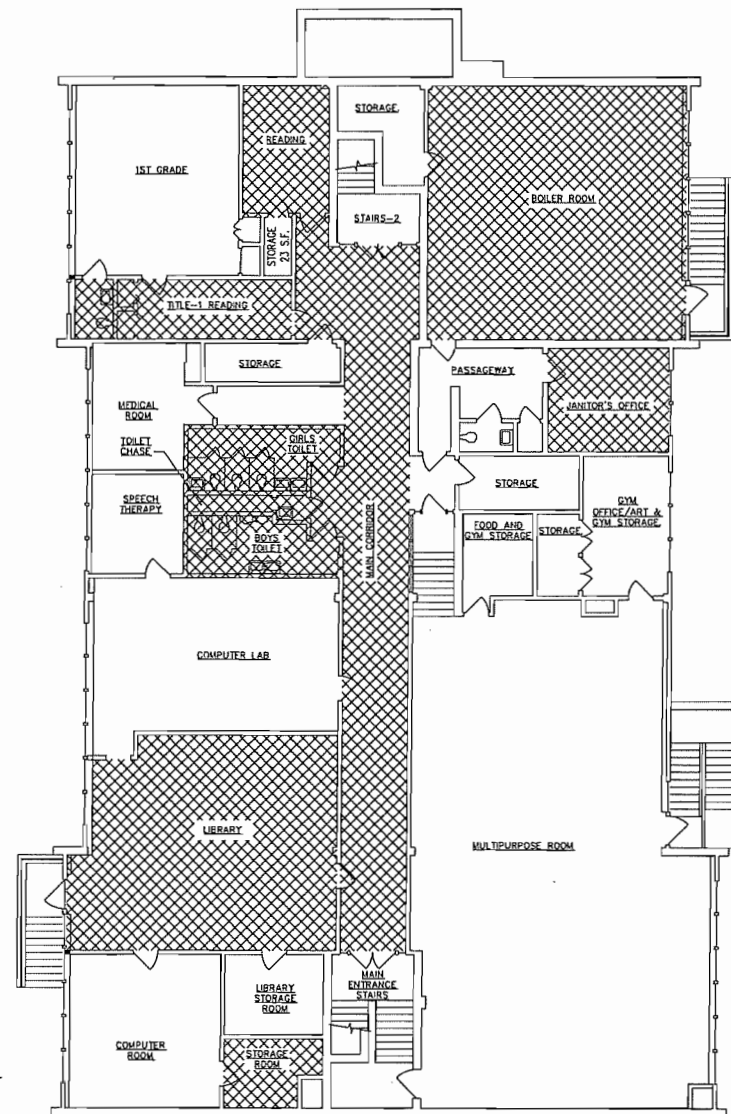
BASEMENT PLAN
NOT TO SCALE

NOTE: ASSUME FITTINGS ARE LOCATED IN WALLS BEHIND SINKS

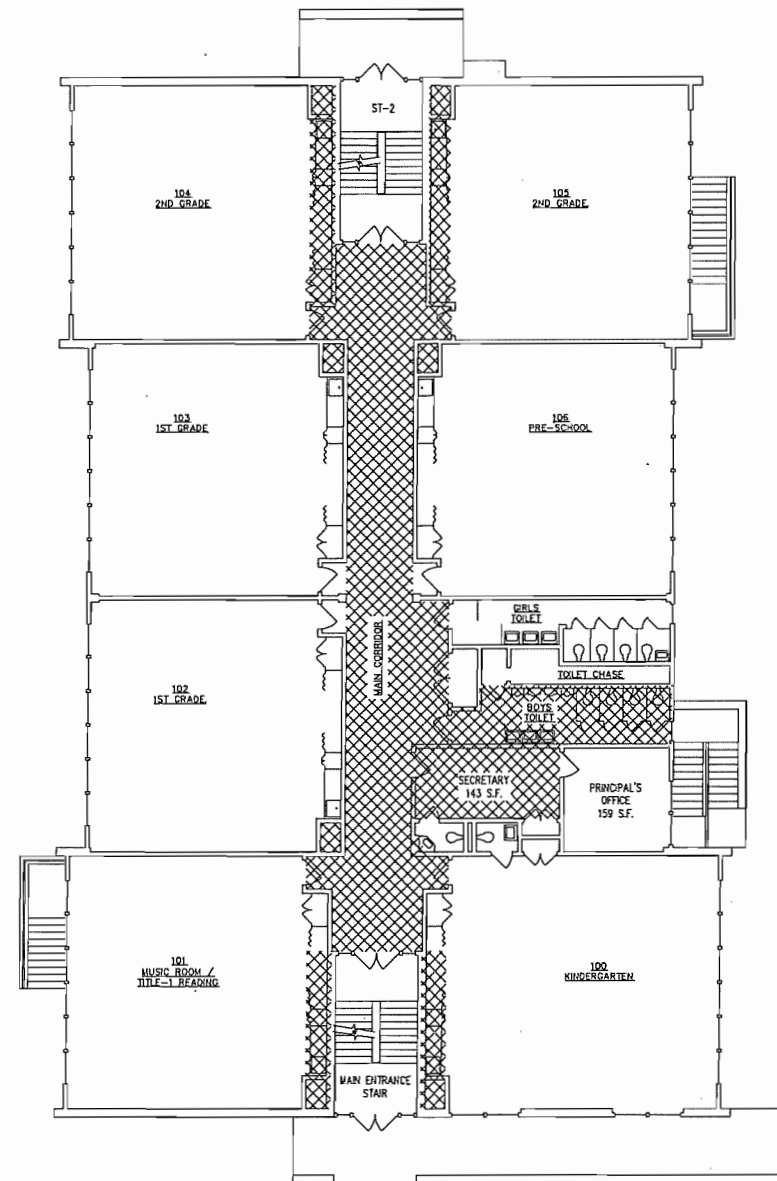
1ST FLOOR PLAN
NOT TO SCALE

NOTE: ASSUME FITTINGS ARE LOCATED IN WALLS BEHIND SINKS

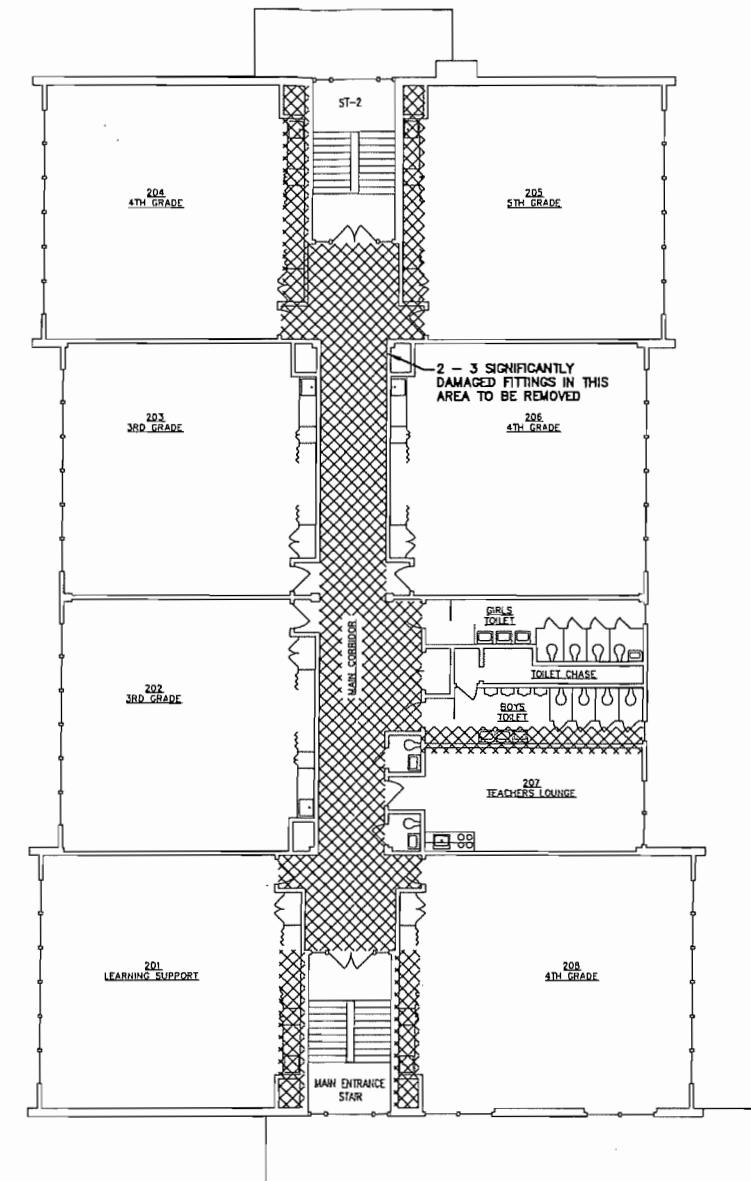
2ND FLOOR PLAN
NOT TO SCALE

NOTE: ASSUME FITTINGS ARE LOCATED IN WALLS BEHIND SINKS

NOTE: ROOF DRAIN FITTINGS
RUN THROUGHOUT BUILDING
ABOVE 2ND FLOOR CEILING
